FO_QAS_Manhole survey card_004_2016 Example

STC25 COMPUTERISED SEWER RECORDS

Node Reference: **SD23458875**

Location: **In footpath, outside No64 Meadow Lane, Salford, Manchester**

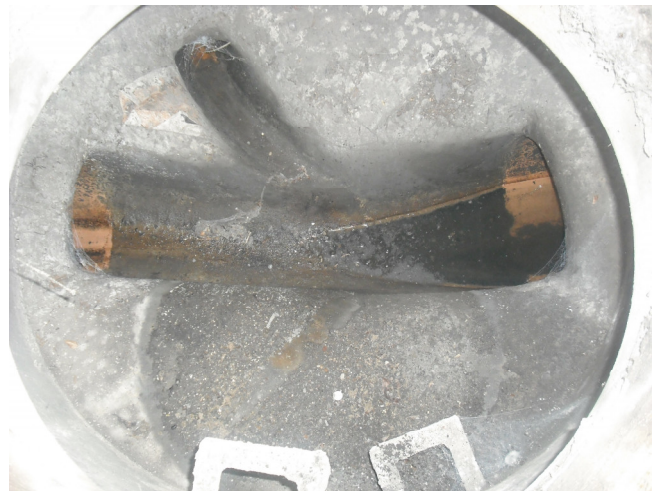
INTERNAL CONDITION PHOTOGRAPH

Offset measurement from centre of cover to centre of channel = 0.23m
Evidence of water ingress to benching
