PROJECT FOCUS

Track drainage failure

Client:
London Underground

Location:
Newbury Park, East London

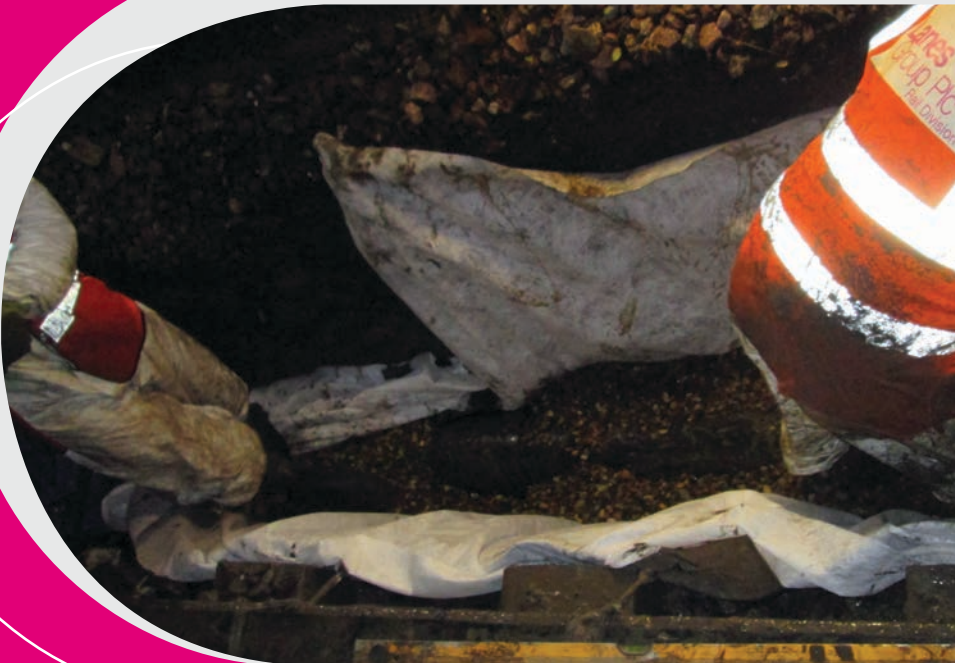
Front cover – Lanes Rail operatives working on a section of track drainage at Newbury Park Station. **This page:** above, a break in the drainage pipe is identified by a Lanes Rail CCTV survey; bottom left, track ballast build up in the drainage pipe; bottom middle, a drainage collapse is uncovered; bottom right, another pipe fracture is identified.

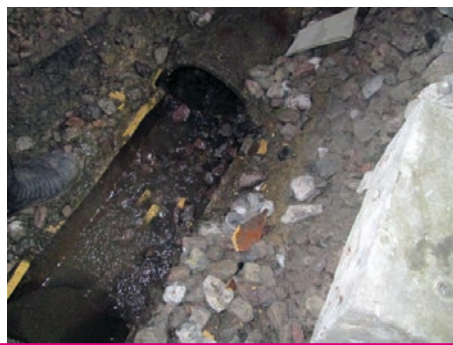
Further investigations by the Lanes Rail maintenance teams found another 22m section of pipe further down the track also blocked by a collapse, and needing to be replaced.

What started as a call to a simple pipe repair, turned into a sizable civils project, with 33m of new drainage pipe laid, and connected to the pump house.
