# LANES IN ACTION

## UV lining flood prevention

Lanes Group was commissioned by Scottish Water to clean and line a combined sewer in the centre of Inverness in the Scottish Highlands, right alongside the River Ness. The 300mm diameter clay pipe had been identified as being at high risk of contributing to localised flooding during heavy rainfall. This would greatly inconvenience local people and create a pollution risk for the river.

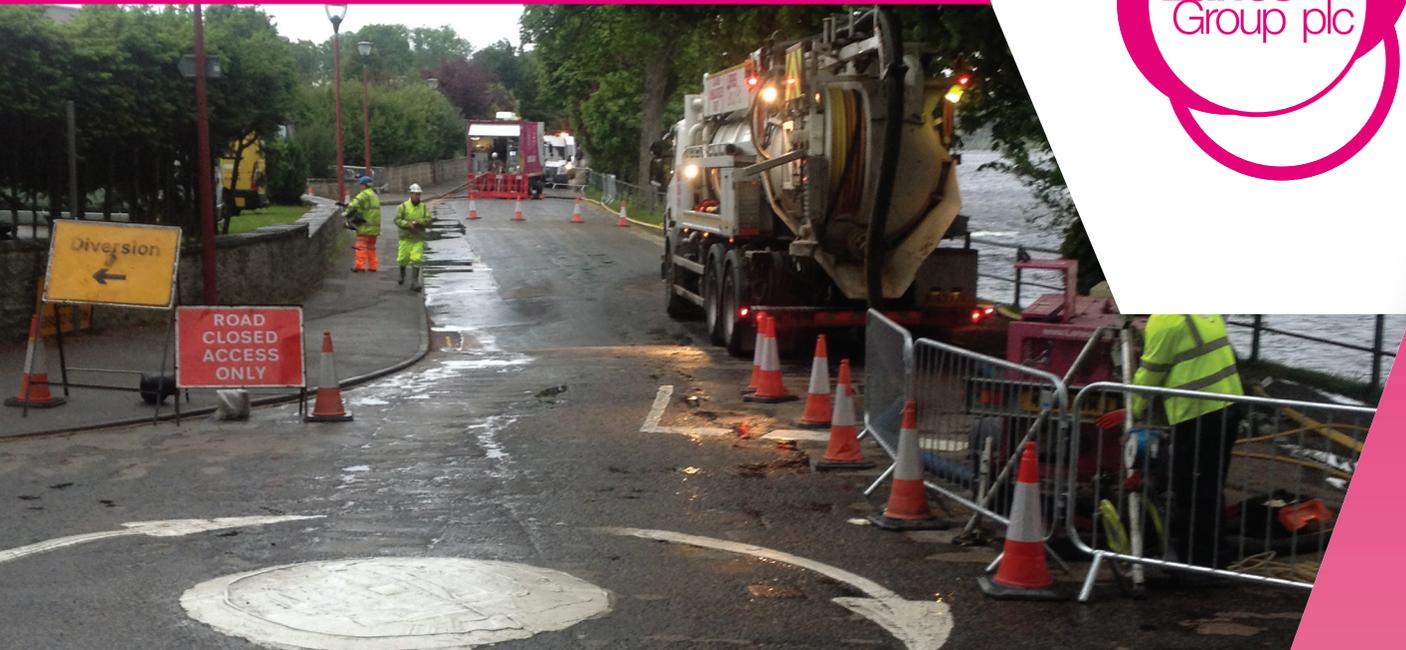
#### Front cover

Lanes sewer rehabilitation engineers work on site – with just a 5-hour window each day.

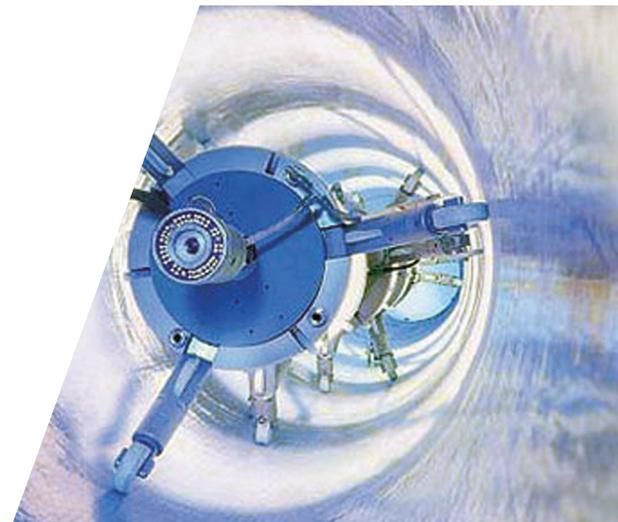
#### This page

Ultra-violet light was used to cure resin in each liner, setting it hard, creating a new pipe-within-a-pipe.

With UV lining, a glass fibre liner is installed in the pipe and inflated against its sides. Then a UV light array is sent through the pipe to cure, or harden, resin impregnated in the liner.
