Lanes Group Case Study

Project:
Irregular culvert relining

Client:
Severn Trent Water

Location:
Leamington Spa

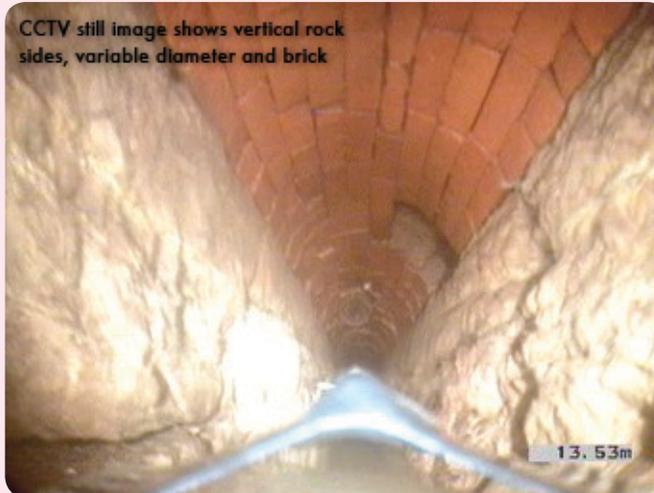
CCTV still image shows vertical rock sides, variable diameter and brick

CCTV survey image shows the irregular rock walls of the culvert.

The culvert was irregularly shaped, with a constantly changing diameter, which meant it could not be measured with profiling equipment. It appeared to have been cut from solid rock, had a flat base and a brick-lined roof. It was badly damaged, with many bricks missing.

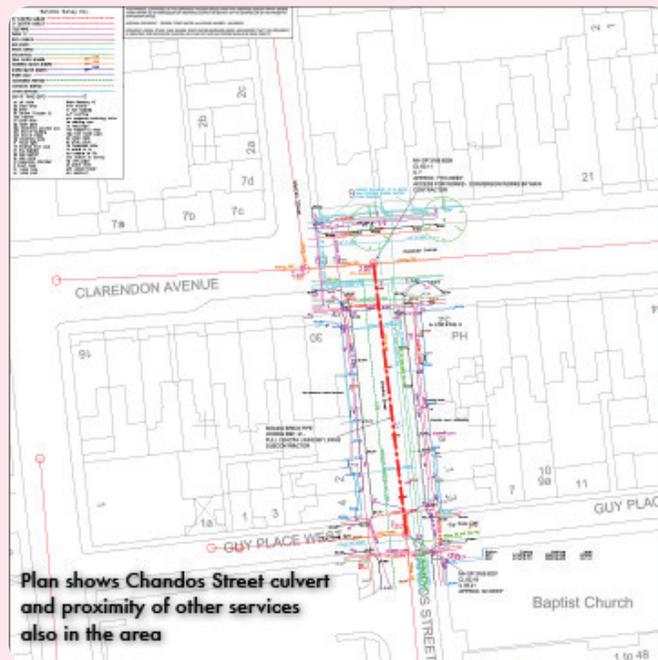
Plan shows Chandos Street culvert and proximity of other services also in the area

A no dig solution was essential to minimise traffic disruption.

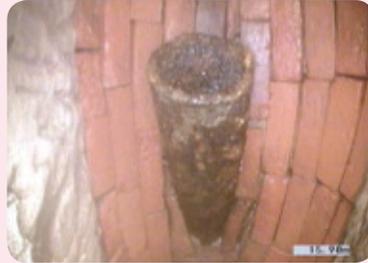
Cut above
CCTV survey image shows the protruding pipe.

The culvert contained eight lateral connections. One of them, a 150mm diameter cast iron pipe, entered through the roof, at an angle, and protruded 500mm into the culvert. Clearly Lanes could not reline over it.

It was not possible to cut it out with a robotic cutter because the culvert narrowed at that point, so the larger KA-TE cutter with the required reach could not get into position. A Prokasro cutter, designed for egg-shaped sewers, was considered, but it did not have the necessary reach either.

It was agreed that a mini excavation should be carried out, just before the liner was installed, to cut the pipe. The excavation would be left open. Then, once the liner was installed, the connection could be cut open from above, and the pipe cemented in place.

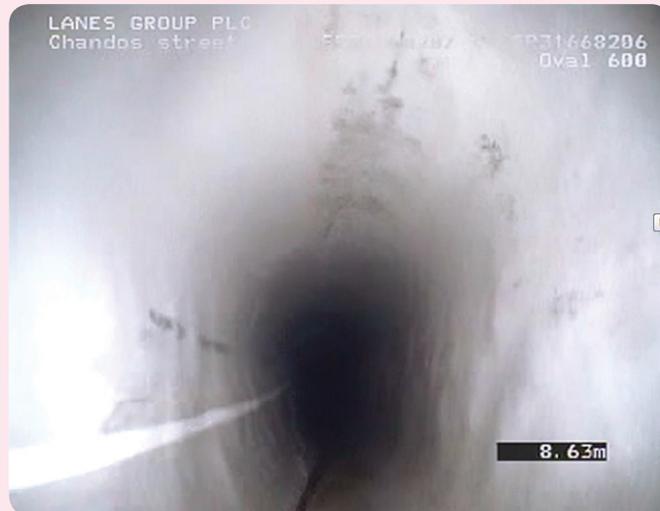
Job done
The culvert with the liner in place.

With everything ready – enabling works complete, materials, plant and equipment in place – installation was scheduled for a weekend to minimise impact on commuting traffic. The 12mm thick liner, installed using the CIPP system, went in smoothly on the Saturday.

A final post-line survey showed that the liner was successfully in place and to a quality acceptable to the client. The irregularly shaped culvert, with its varying diameter and now non-protruding connection, was once again structurally sound.
